service bulletin

TRACK-TYPE TRACTORS • NOVEMBER 18, 1955

STEERING CLUTCHES ¹²

D8 Tractors 2U21513 and up, and 13A1 and up

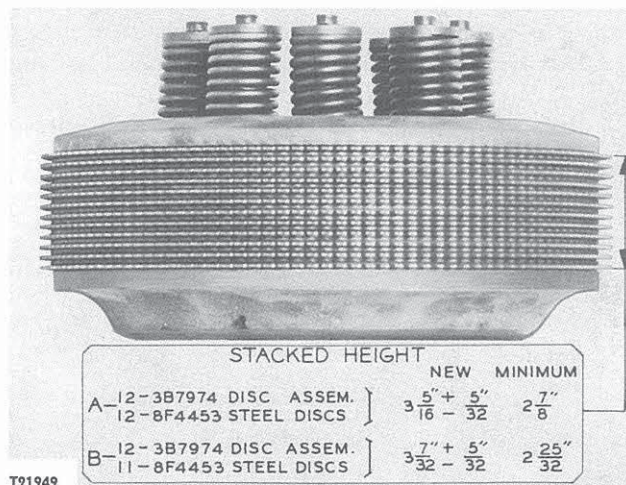
FIGURE 1—Stacked height dimensions of the 11 steel discs and 12 steel disc clutch assemblies. Removal of one steel disc does not affect clutch capacity.

Steering clutch assemblies on these machines contained twelve 3B7974 Disc Assemblies and twelve 8F4453 Steel Discs. The 8F4453 Steel Disc assembled next to the 3H3718 Hub Assembly (pressure plate) has occasionally warped, causing clutch drag. Removal of this steel disc does not affect clutch capacity.

The total stacked height of twelve 3B7974 Disc Assemblies and eleven 8F4453 Steel Discs is $3\text{-}7/32'' \pm 5/32''$. If the stacked height of the discs measures less than $2\text{-}25/32''$, the 3B7974 Disc Assemblies should be replaced as the clutch may slip.

For clutches with twelve 3B7974 Disc Assemblies and twelve 8F4453 Steel Discs, the total stacked height is $3\text{-}5/16'' \pm 5/32''$. If the stacked height of the discs measures less than $2\text{-}7/8''$, replace the 3B7974 Disc Assemblies.

When steering clutches of D8 Tractors 2U21513 and up and 13A1 through 13A2227 are reconditioned, the steel disc next to the pressure plate should be omitted. When steering clutches are reassembled, the total stacked height of the discs should be measured to assure that the correct num-

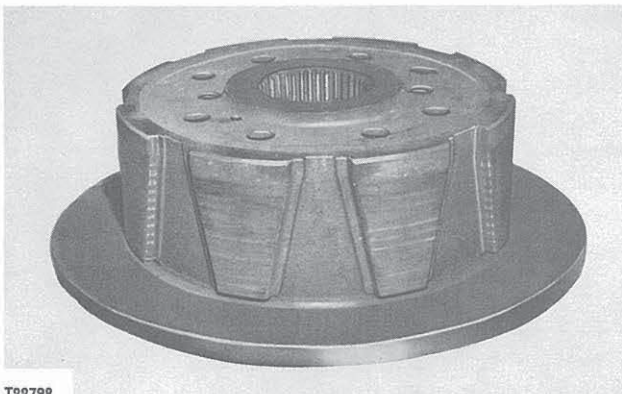
T22798

Service Reports and parts returned to the factory indicate that many steering clutch inner drums of the helical lug type used in D8 Tractors 2U21513 and up, 13A1 and up, Series D and E and No. 583 Pipelayers are being replaced unnecessarily. It appears that the wavy wear pattern which develops across the helical cut lugs has led servicemen to replace inner drums on the assumption that this would cause the clutch discs to "hang up", resulting in slippage.

This is not the case, since such wear patterns are normal and do not affect steering clutch capacity. The notches or steps produced are angled rather than square and do not hinder free engagement of the discs.

FIGURE 2—Wavy pattern on drive lugs does not affect clutch operation.

If inspection of steering clutch inner drums reveals wear such as that shown on the lugs, but the

drums are otherwise sound, the drums should be reinstalled. Care must be taken, however, to follow the correct assembly procedure. If the same discs are to be reinstalled, their positions in the stack can be rearranged to provide better wear distribution. Each disc must be installed with the same face up as was used in the previous assembly.

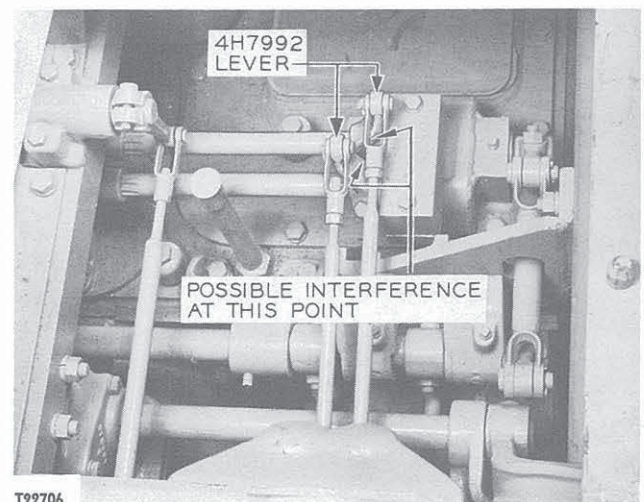
T22706

Two 4H7992 Levers are used in the steering clutch control linkage of D8 Tractors (Series D and E) and No. 583 Pipelayers. On some of the first of these machines the rear lever (for left hand steering clutch) could interfere with the forward lever when the left hand steering clutch control lever was pulled all the way back. This interference could move the forward lever enough to partially release the right steering clutch.

FIGURE 3—Should interference occur between steering clutch levers, grind the rear lever to increase clearance.

Field correction of this problem is quite easily made by grinding the necessary material off the rear lever to eliminate any interference. The 4H7992 Lever has now been modified so there will not be any interference. There is no change in part number.
