DIAGNOSING Tyrone Gear Pump Failures

HYDRAULIC GEAR PUMP FAILURE ANALYSIS

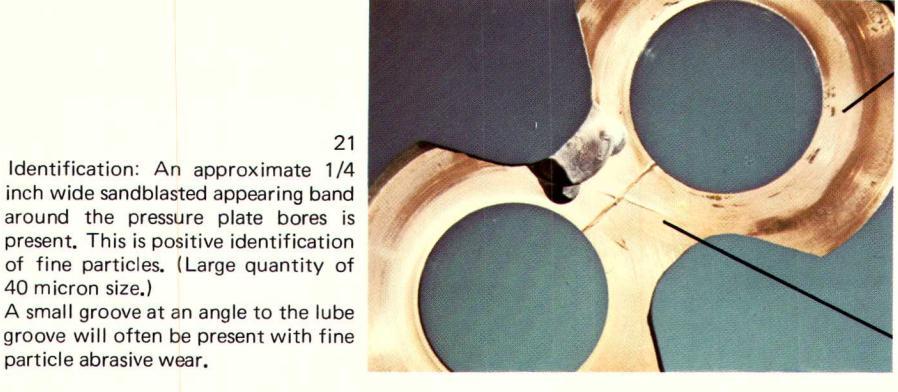
SANDBLASTED BAND

ANGLE GROOVE

22 Identification: Contamination by fine particles will cause the edges of the lube groove to be rounded and the ends to be enlarged.

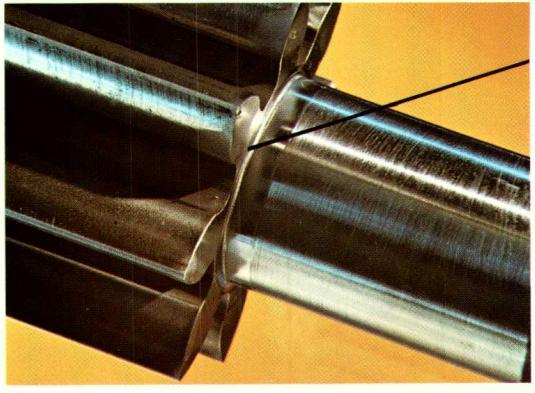
23 Identification: A dull sandblasted area may appear at the root of each tooth at the face of the gear. This is caused by contaminated oil flowing down the lubrication groove.

The shaft will have a dull finish the length of the bearing surface as if it had been sanded with fine sandpaper. This is caused by fine abrasive particles from the oil being embedded in the bearing. Either or both conditions may show up depending on

DULL AREA AT ROOT OF TOOTH

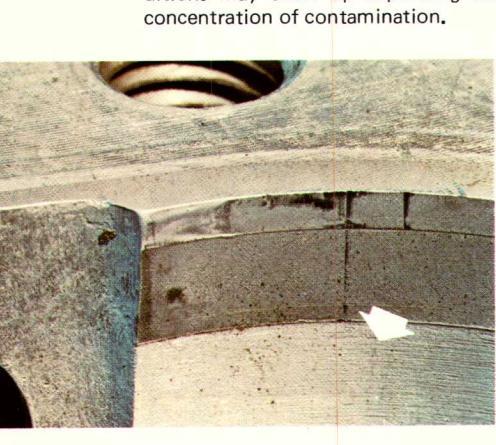
Identification: Contamination by fine particles will cause the gear track to be gray with a sandblasted appearance. This will occur at the inlet side only.

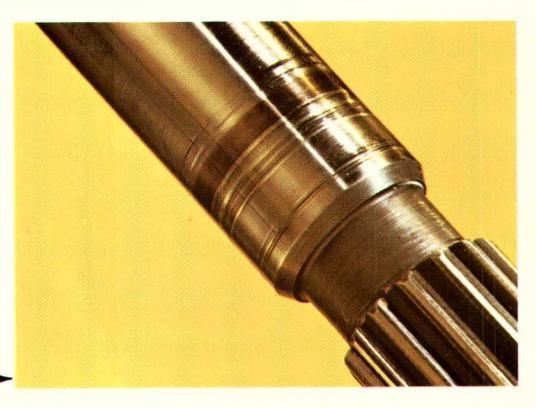
Identification: The seal lip will cut into the shaft. Fine abrasive particles will get under the seal lip and 25wear grooves in the shaft.

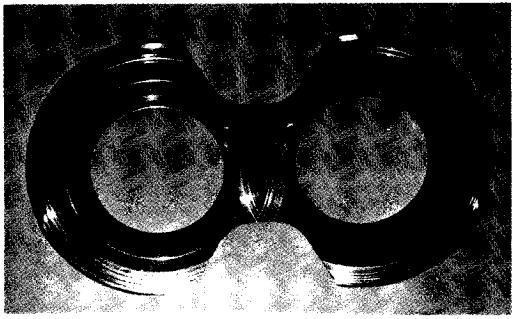
Identification: The pressure plate will have many circular scratches caused by particles of more than 100 microns in size. If exposure to this size particle is continued long enough, the entire surface will be very rough and heavily grooved.

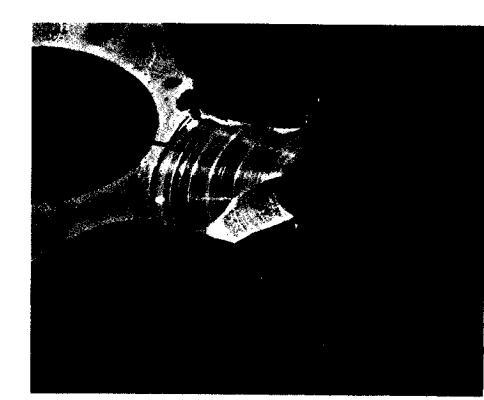
29 Identification: Wear will be visible on the pressure plate at rear of drive gear only. This is caused by the drive shaft bottoming out in the machine drive coupling. This puts heavy thrust load on drive shaft.

Incorrect installation can impose external loads on the pump which cause various failures. Be sure drive shaft does not bottom in mating part. Piping should be attached to the pump without force. Pump should clear all machine components in all types of operation.

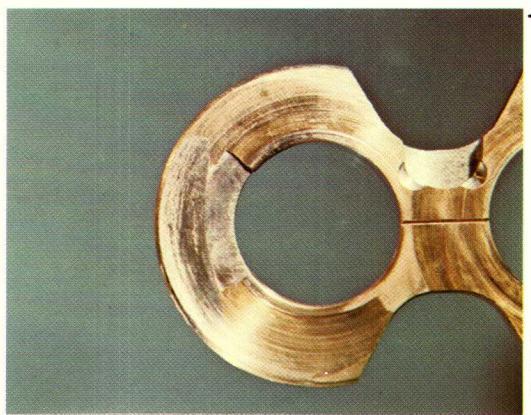
Identification: There will be heavy wear on the end of pressure plate. Low oil level may allow the suction to be completely uncovered for short periods of time. This can occur during machine operation (due to sloshing action) even though suction may be well below oil level when the machine is not moving.

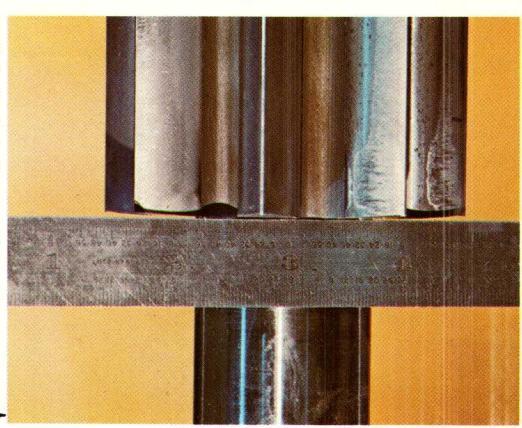
Identification: Heavy wear on end of gear usually occurs on both ends of gear. The wear is greater near the outside diameter. 35

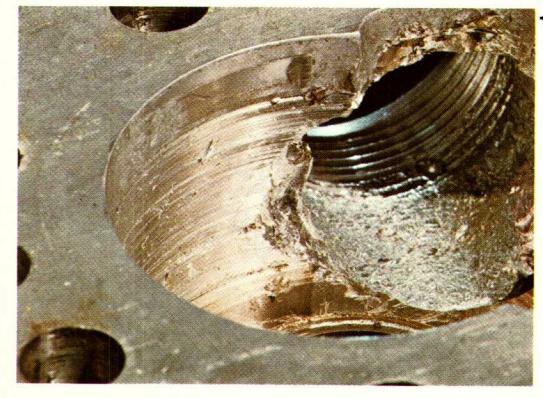
Identification: There will be deep grooves cut into the housing. Created by any large metal object, such as a nut or bolt, entering the suction side of the pump. This causes deep grooves in the pump housing, and may cause heavy peening in the pump inlet port.

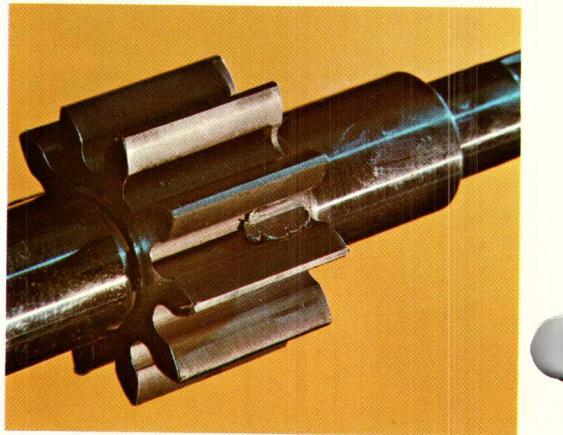
Identification: Soft metal object caught in gear teeth will cause the pump to lock up. 39+

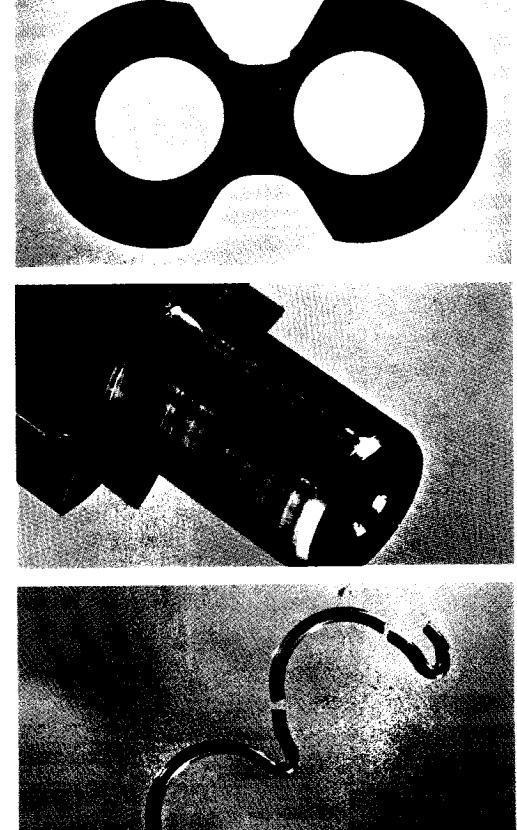
Identification: Entire plate will be coated with a black substance. Surfaces otherwise will show very little damage. Oil temperatures of well above 300° F are required to cause this type of damage. The plate cannot be reused.

Identification: Shaft and gear will be black all over. Shaft will show some bright streaks but no real grooves. Oil temperatures of well above 300° F are required to cause this type of damage.

Identification: Seal strip will be extremely hard and brittle. It will snap like glass. Oil temperatures of well above 300° F will cause this condition in a few hours. Long exposure to temperature of 225° F will harden this part but it will still have some flexibility.

Parts are not reusable. The bearing surfaces are damaged by such excessive temperatures.

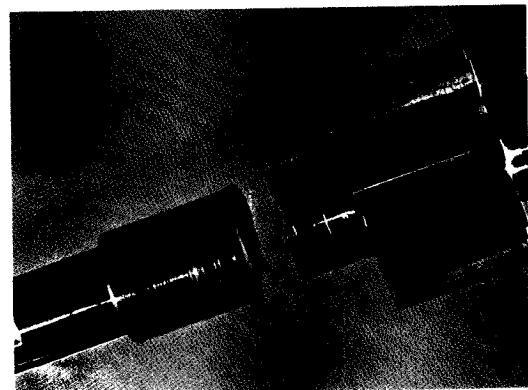
Identification: The shaft will break. This type of failure may be caused by failure of the relief valve to function or by repeated surges of excessive pressure.

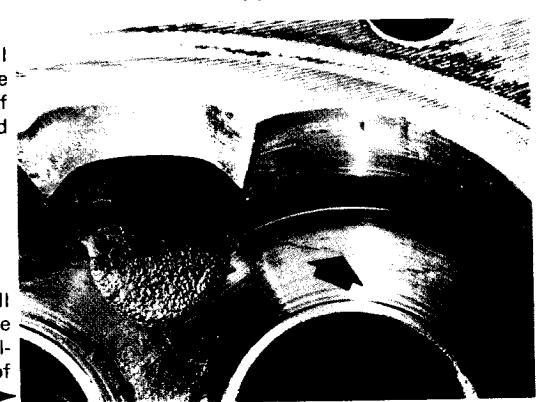
Identification: The housing will crack. This type of failure may be caused by relief valve malfunction, or by repeated surges of excessive pressure. 44

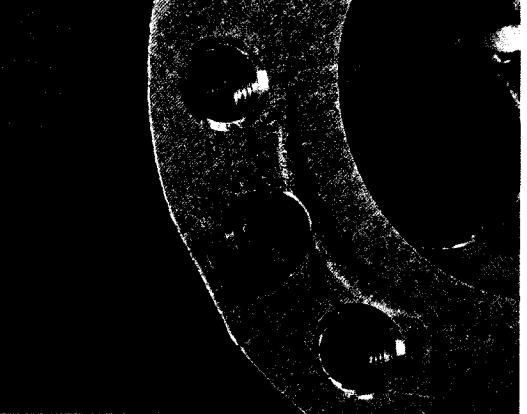
Identification: The surface of the housing will show a depressed area. This is caused by the O-ring being squeezed as shown in Figure 45.

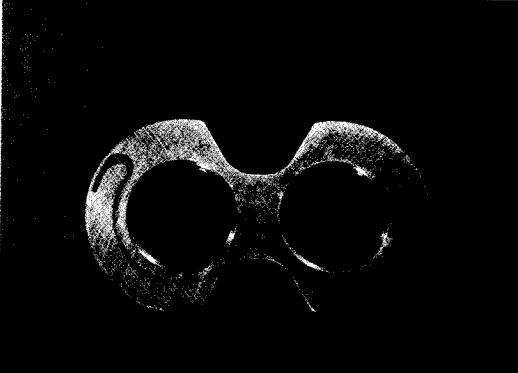
48

Identification: The sealing strip usually leaves a faint print on the steel side of the pressure plate. This print should be directly behind chamfer and traps. Observing this print makes it possible to determine if pump was properly assembled.
