DIAGNOSING Tyrone Gear Pump Failures

HYDRAULIC GEAR PUMP FAILURE ANALYSIS

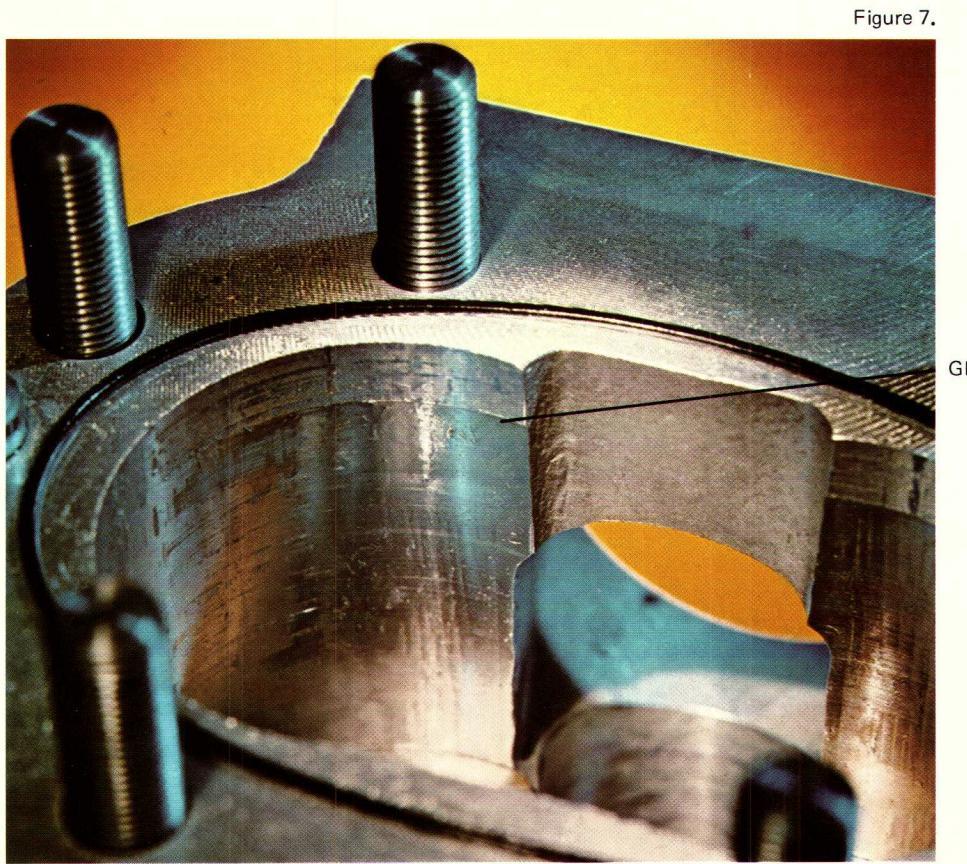
The suction side of the pump housing is shown in Figure 7. During initial break-in at the factory, the gears cut into the housing. The nominal depth of this cut is .008" (0,203 mm) and should not exceed .015" (0,381 mm). This gear track provides low gear tip clearance and high volumetric efficiency. Note the smooth machined appearance of the gear track. Small bits of metal are sometimes pulled out of this surface during break-in. This is not detrimental.

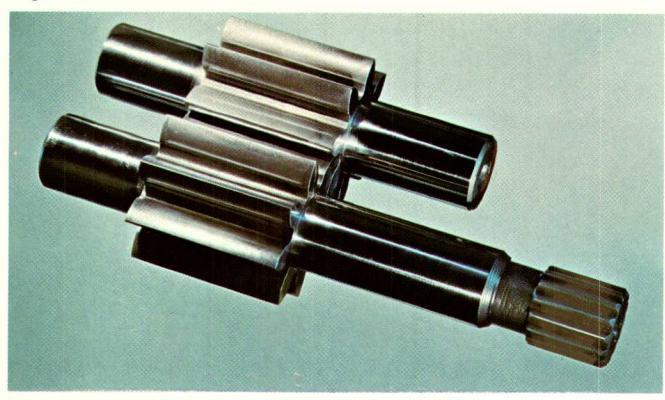
The drive and idler gears from a properly operating pump are shown in Figure 8. Note the polishing of the loaded side of the gear teeth. Some pitting near the root of the tooth will occur after extended operation. The high gloss of the journals also indicates a properly operating pump.

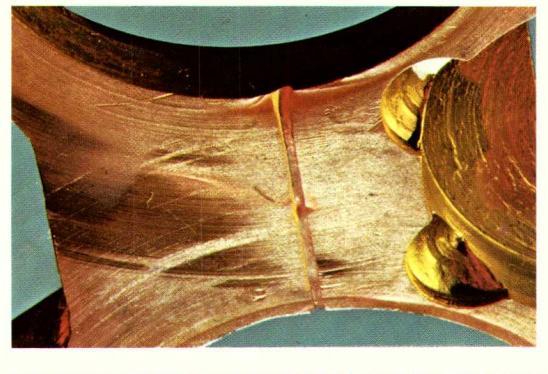
SANDBLASTED BAND

ANGLE GROOVE

22 Identification: Contamination by fine particles will cause the edges of the lube groove to be rounded and the ends to be enlarged.

23 Identification: A dull sandblasted area may appear at the root of each tooth at the face of the gear. This is caused by contaminated oil flowing down the lubrication groove.

Dirt can enter the system through worn seals, or if the system is serviced in dusty conditions, or with dirty equipment. Always wipe tank caps, funnels, and all areas around the filler neck clean before opening the tank. Immediately cover all disconnected lines, fittings and openings. Check the rod wiper seals to be sure they are operating effectively.
